# Manhole Inspection Summary

Manhole # S07WW\_011MH

Insp Date: **7/17/07 11:08 AM**

**Location** Address: **REAR 3705 FOREST PARK AVE** Cross Street: **CALLAWAY AVE**

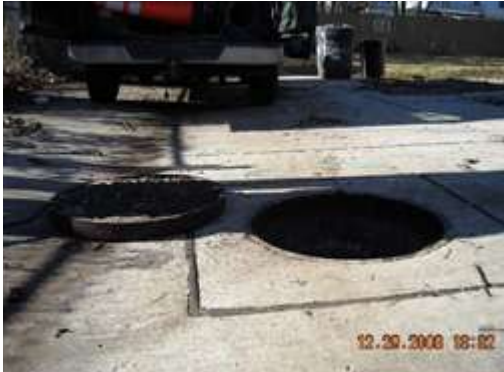
EVIDENCE OF INFLOW DUE TO SHEETING IN ALLEY AS WATER FLOWS TOWARDS DRAINAGE

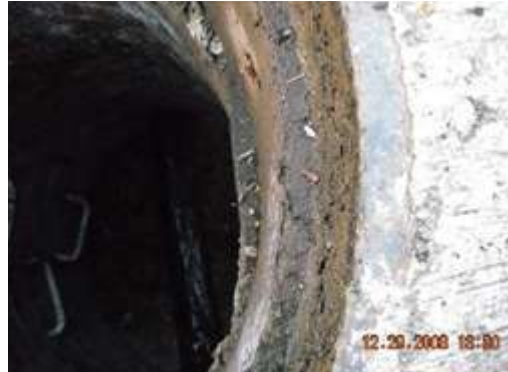
Defect 1

**Frame** Offset: **1** (in.) Condition: ☒ Sound ☐ Cracked ☐ Leaks

FRAME OFFSET 1"

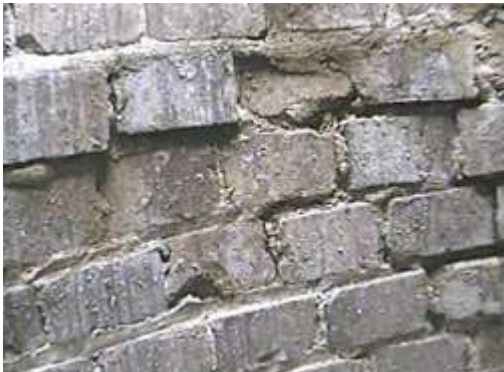
Defect 4

Condition: ☐ Sound ☐ Cracked ☐ Root Intrusion ☐ Loose Brick ☒ **Deteriorated**

Condition: ☐ Sound ☒ **Cracked** ☐ Root Intrusion ☐ Loose Brick ☒ **Deteriorated**

DETERIORATION OF BRICKS IN BARREL/CORBEL WALL AND AT JOINT

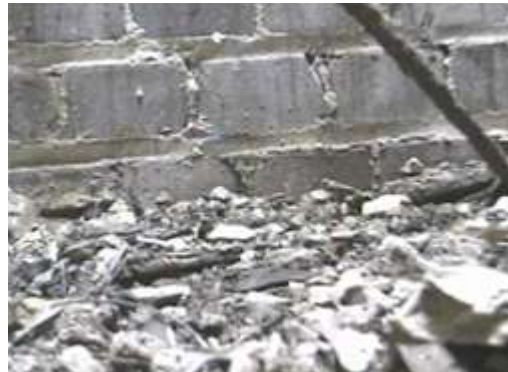
Defect 3

Condition: ☐ Sound ☐ Cracked ☐ Root Intrusion ☐ Deteriorated ☐ Leaks ☒ **Debris**

DEBRIS ON BENCH

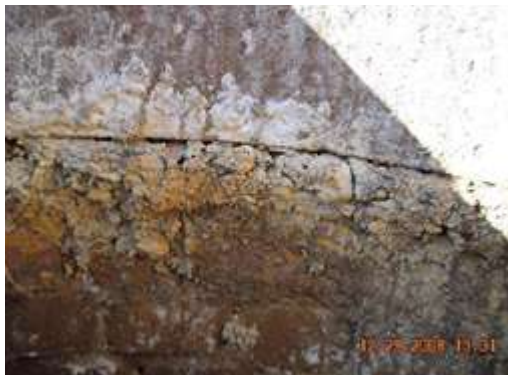
## Defect 2

**Chimney / Frame Adjustment** ☒ Exists Material: **Brick and Concrete** ☒ Parged Height: **3** (in.)

CHIMNEY ADJUSTMENT 3"

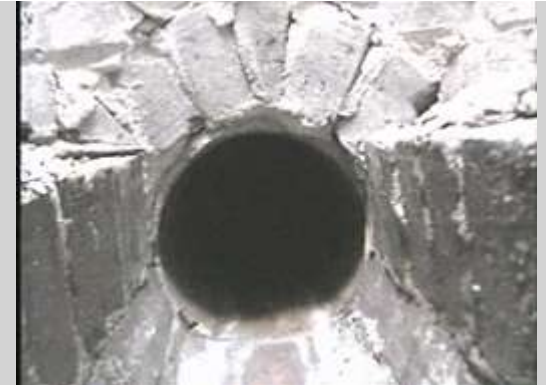
12 O'Clock Outflow

10 in. Circular Gravity Sewer  
Pipe Out @ 12 O'Clock

Pipe Height: **9.6** (in.) Rod and Bar (Angled)  
Pipe Material: **Clay** ☐ Pipe Lined  
Invert Depth: **7.92** (ft.) Flow Characteristics: **Slow**  
Deposits: ☒ None ☐ Mud ☐ Sludge ☐ Debris ☐ Grease  
Silt Depth: (in.) Deposits Extent:  
Infiltration: **None** Pipe Seal Cond: **Sound**

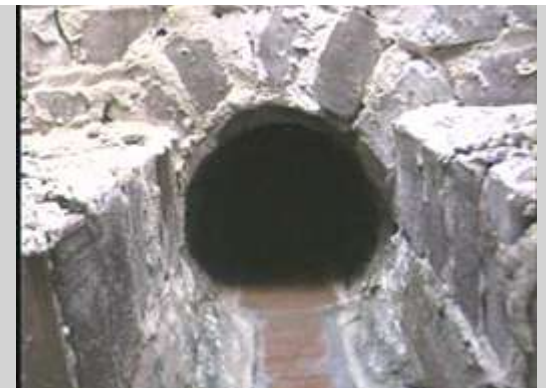
6 O'Clock Inflow

10 in. Circular Gravity Sewer  
Pipe In @ 6 O'Clock

Pipe Height: **9.6** (in.) Rod and Bar (Angled)  
Pipe Material: **Clay** ☐ Pipe Lined  
Invert Depth: **7.93** (ft.) Flow Characteristics: **Slow**  
Deposits: ☒ None ☐ Mud ☐ Sludge ☐ Debris ☐ Grease  
Silt Depth: (in.) Deposits Extent:  
Infiltration: **None** Pipe Seal Cond: **Sound**
